SOMETHING GREEN A DAM
WASHINGTON COUNTY, MISSOURI
MO 30720

SOMETHING GREEN B DAM
WASHINGTON COUNTY, MISSOURI
MO 30719

PHASE 1 INSPECTION REPORT NATIONAL DAM SAFETY INSPECTION

SEPTEMBER 1980

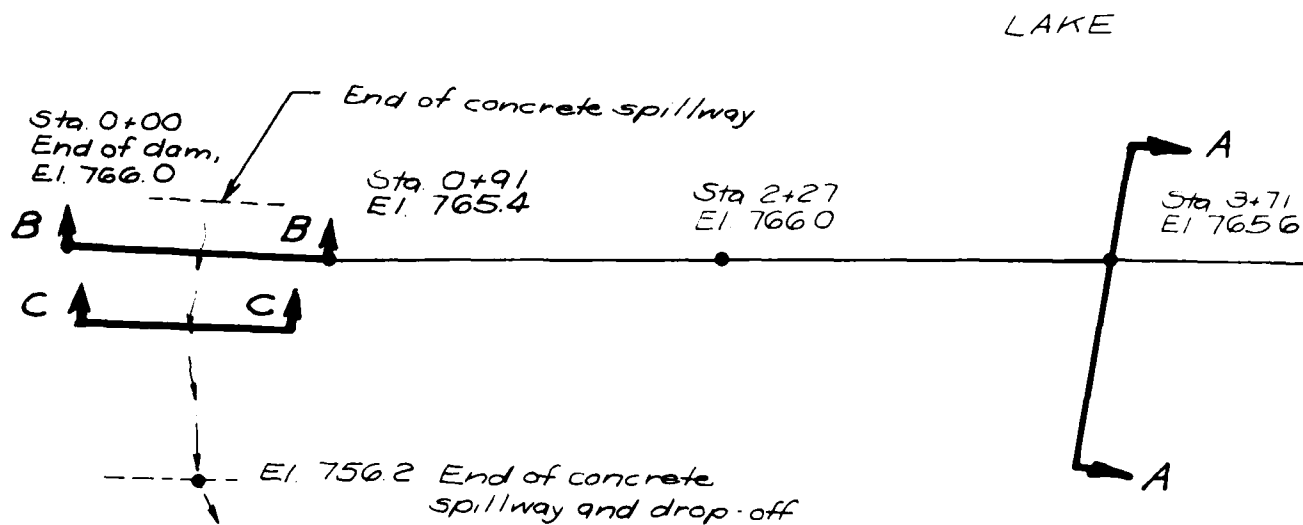
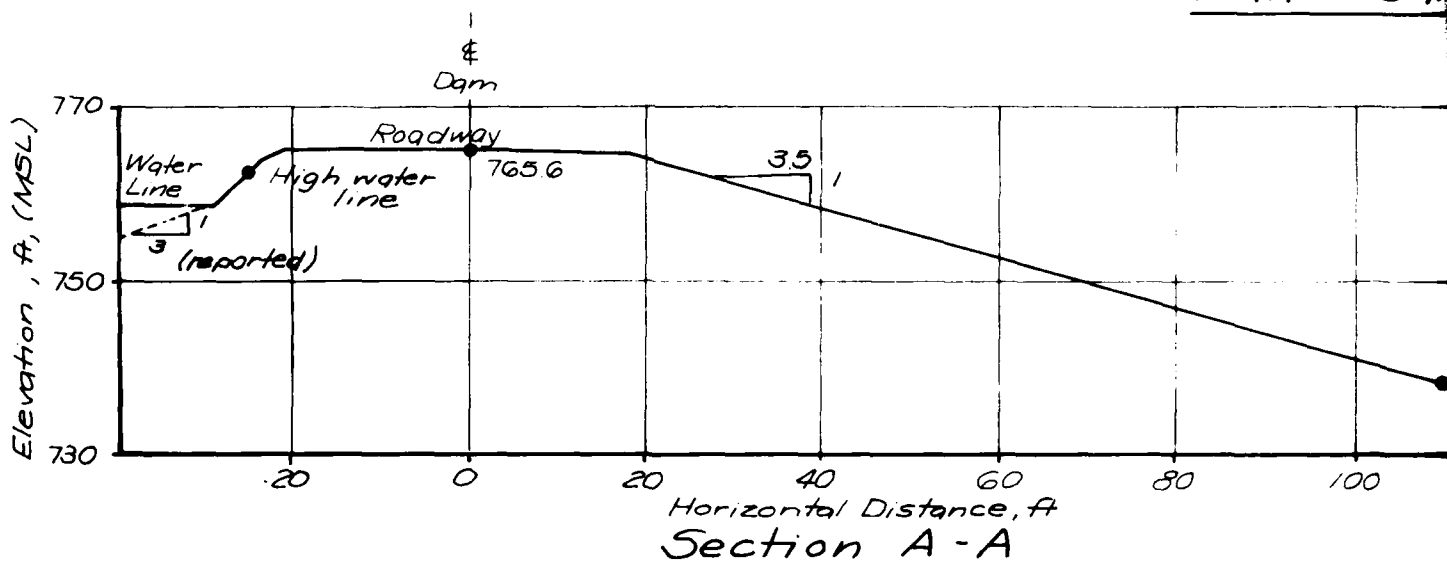
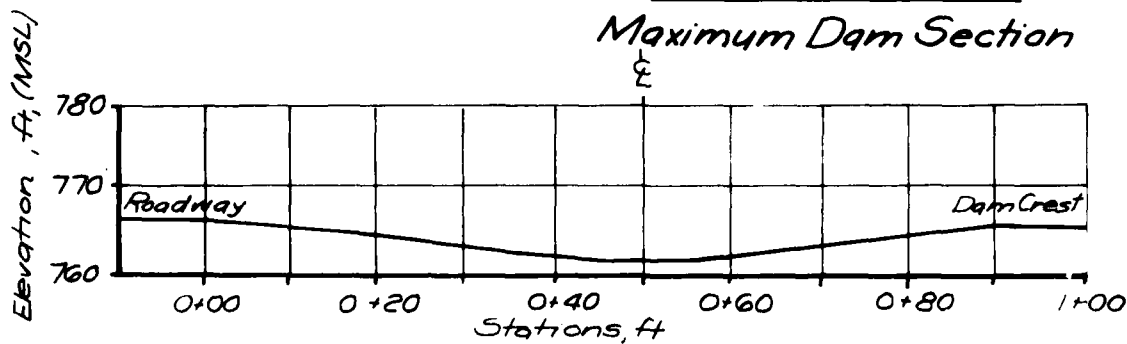
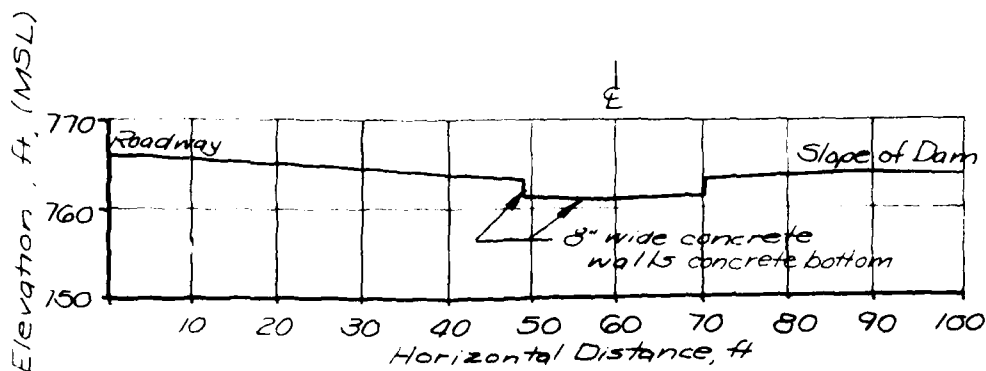
Fig. 3

The spillway is a broad trapezoidal concrete-lined weir at the dam axis and a rectangular concrete chute upstream and downstream of the weir. The trapezoidal weir has a controlling width of approximately 48 ft (Photo 1). The low point controlling outflow is at elevation 761.1 ft, about 4.3 feet below the crest of the dam. Approximately 25 ft downstream from the crest of the spillway, discharge flows are channeled into a 2 ft deep, 21 ft wide rectangular chute which extends 55 ft downstream to about a 4 ft eroded dropoff (Photo 2). There is no cutoff at the end of the chute to protect against undercutting.

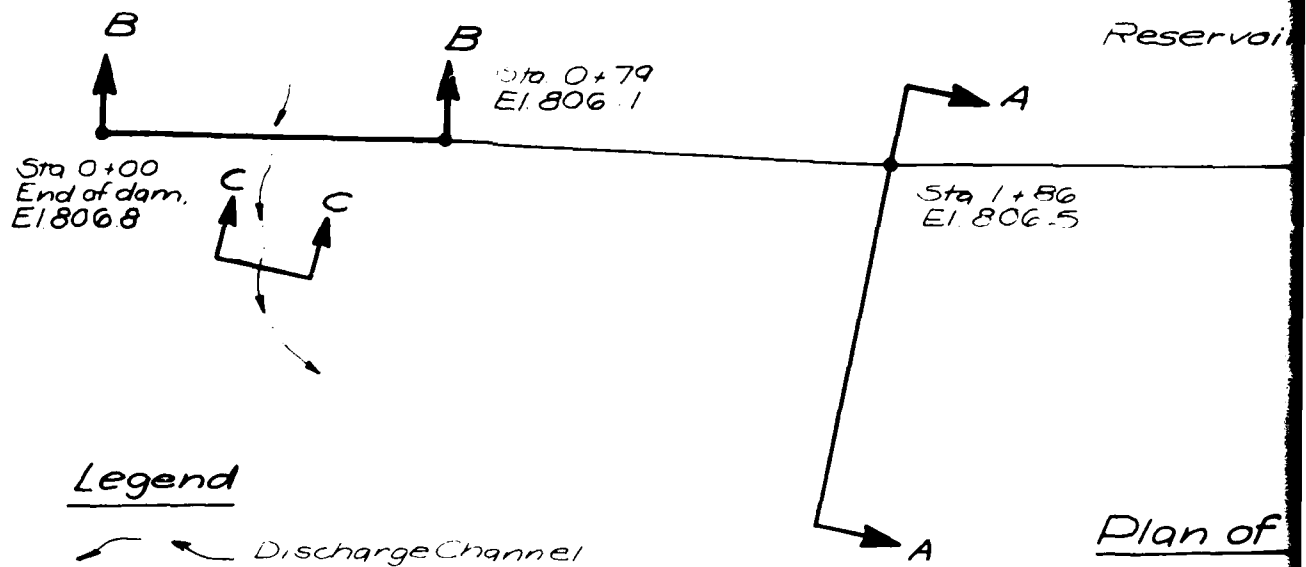
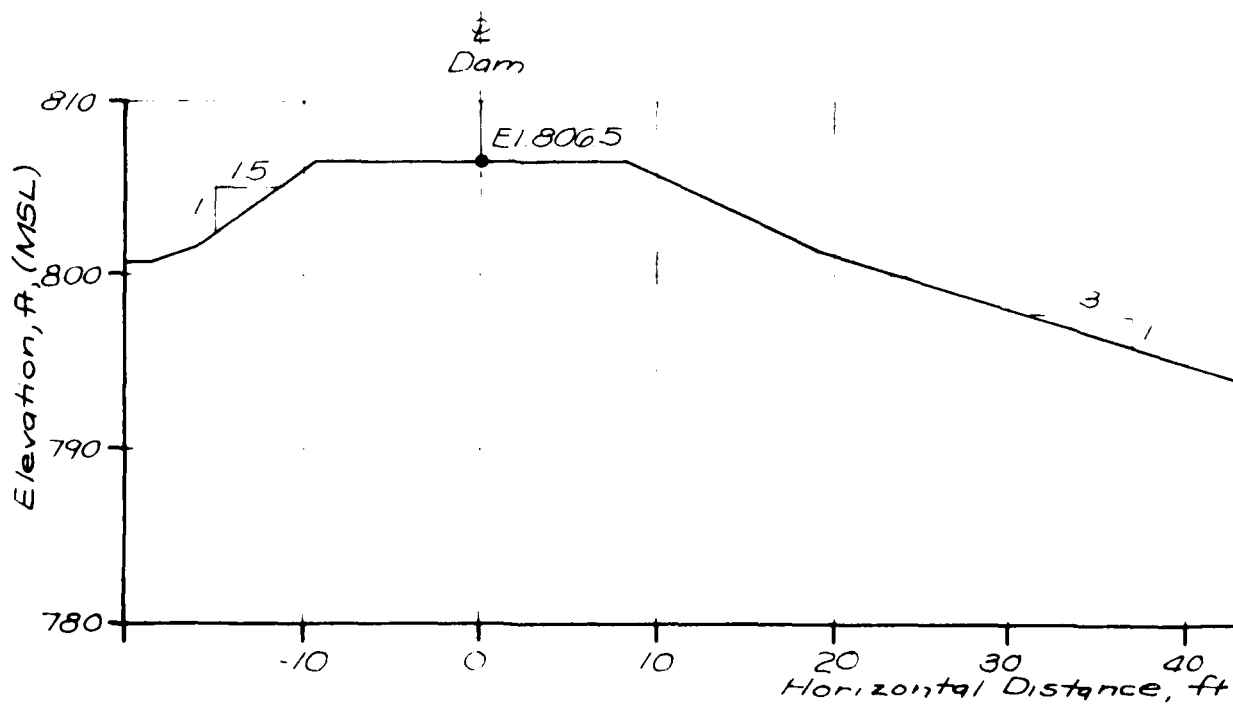
Fig. 3-A

- a. Description of dam and appurtenances. The Something Green B Dam is an earth fill dam impounding a recreational lake in north-central Washington County, Missouri (Fig. 1). The dam is approximately 447 ft in length and retains the impoundment on the northeast (Fig. 2). The dam is approximately 22 ft high at the maximum section. Elevations along the dam crest are nearly uniform at slightly over 806 ft MSL.

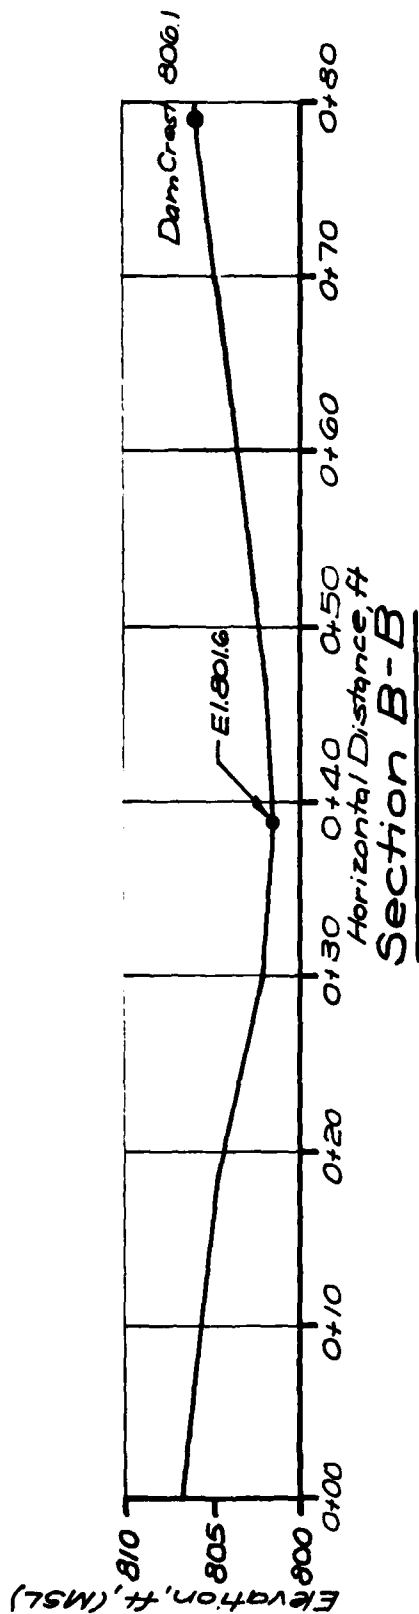
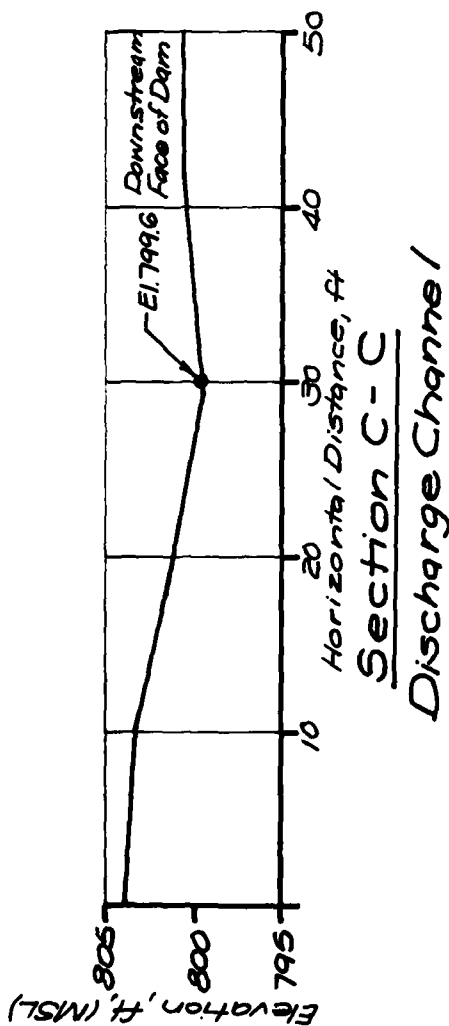
SECTIONS OF SPILLWAY AND DISCHARGE CHANNEL	
SOMETHING GREEN B DAM	
MO. 30719	FIG 3B

The discharge channel below the lined portion of the spillway is eroded to bedrock (Photo 2). The discharge channel walls are residual stoney clay, which appears to be moderately erodible.

e. Downstream channel. The downstream channel below the spillway apron consists of a bedrock floored, soil walled, eroded gully, approximately 2 to 4 ft deep and 15 to 25 ft wide (Photo 2). The exposed bedrock consists of blocky dolomite, Eminence Formation. The owner indicated he plans on excavating
